Manhole Inspection Summary

Manhole # **S39GG_021MH**

Insp Date: **6/20/08 5:10 PM**

Location Address: **OLIVER ST**

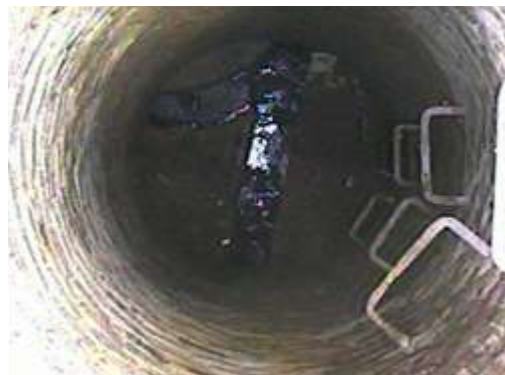
Defect 1

Count: **6** Missing: **0** ☒ **Corroded**

STEPS CORRODED

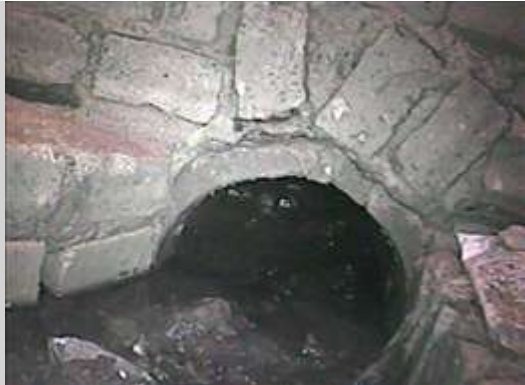
12 O'Clock Outflow

8 in. Circular Gravity Sewer
Pipe Out @ 12 O'Clock

Pipe Height: (in.) Direct
Pipe Material: **Clay** ☐ Pipe Lined
Invert Depth: **10.66** (ft.) Flow Characteristics: **Slow**
Deposits: ☐ None ☐ Mud ☒ **Sludge** ☐ Debris ☐ Grease
Silt Depth: **2** (in.) Deposits Extent: **Heavy**
Infiltration: **None** Pipe Seal Cond: **Sound**

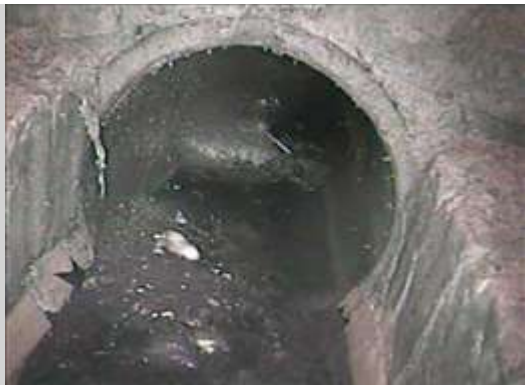
6 O'Clock Inflow

8 in. Circular Gravity Sewer
Pipe In @ 6 O'Clock

Pipe Height: (in.) Direct
Pipe Material: **Clay** ☐ Pipe Lined
Invert Depth: **10.63** (ft.) Flow Characteristics: **Slow**
Deposits: ☐ None ☐ Mud ☒ **Sludge** ☐ Debris ☐ Grease
Silt Depth: **2** (in.) Deposits Extent: **Medium**
Infiltration: **None** Pipe Seal Cond: **Sound**

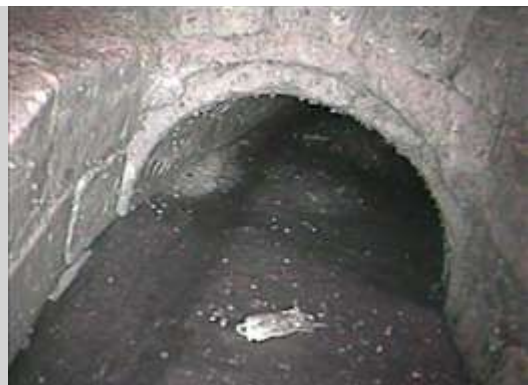
9 O'Clock Inflow

Deposits: ☐ None ☐ Mud ☒ **Sludge** ☐ Debris ☐ Grease

Silt Depth: **2** (in.) Deposits Extent: **Medium**
